SERVICE BULLETIN

Classification:	Reference:	Date:
BT05-025a	NTB05-042a	June 28, 2005

WINDOW REGULATOR CREAK NOISE AFTER OPENING

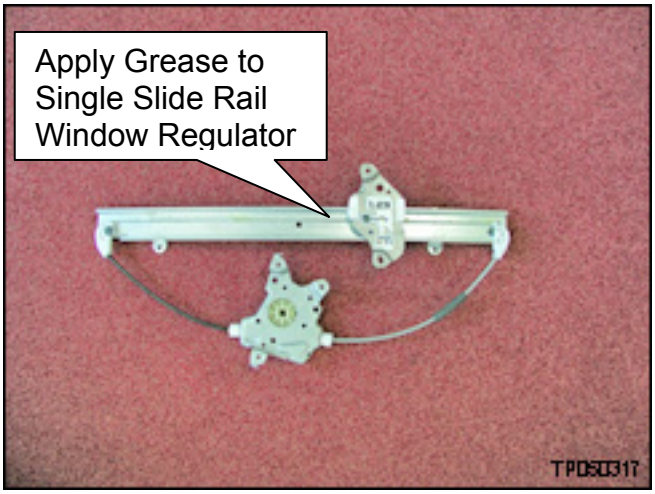
Figure 1

There is a creak noise during window movement after the window is opened approximately a quarter of the way from the fully closed position.

The window glass continues to move down slightly after the window button is released and makes a creak noise.

1. Remove the front door glass regulator assembly from the side that is making noise.
   - Refer to the Electronic Service Manual (ESM), section GW, for removal instructions.
2. Clean/wipe off all of the old existing grease from the front window regulator slide rail.
